Parappa

NEWSLETTER OF THE BOAT "PARAPPA" ISSN 1835-4548 JUNE 2009 NO. 6

Parappa - 94 years of maintenance and modernisation

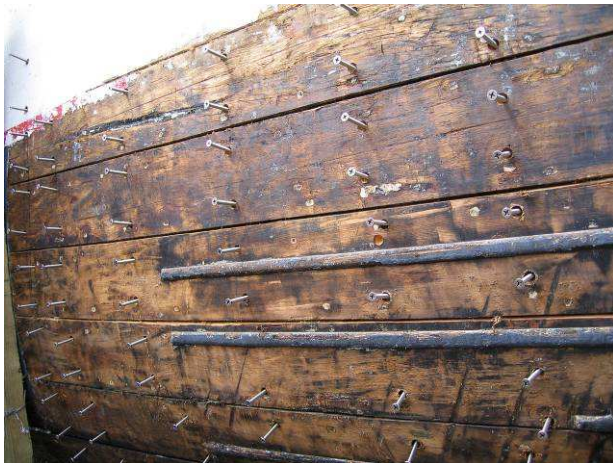
Re-screwing the planks to the rib timbers

The first task in the refit was to re-screw the planks below the waterline. Scraping off the antifouling by hand exposed the bare huon pine planks, in excellent condition after 90 years in the water, with butt joins as sharp as the day they were cut. Using the rows of copper nails as a guide to the position of the ribs, two 316 grade stainless steel screws were put into every plank at each rib. A huon pine plug was glued over each screw and sanded smooth. Above the waterline,

the same procedure was used, but with only one screw per intersection. The re-screwing tightened the hull substantially, pulling planks up to the ribs, sometimes by as much as 6 mm.

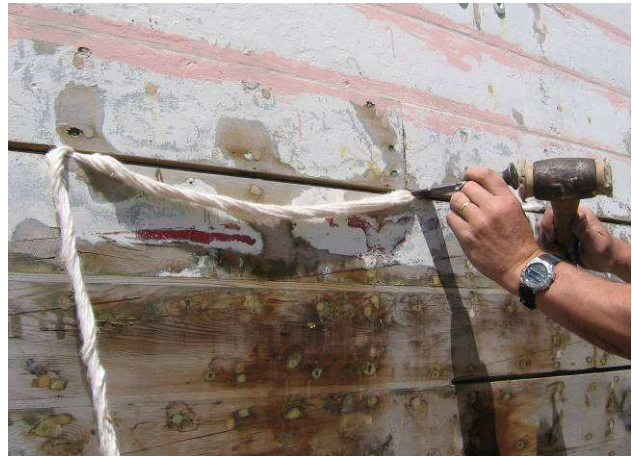
Hammering in caulking above the waterline

removing old putty and some of the caulking, and opened up to a standard width with a circular saw or router. The boat was no doubt built with seams of uniform width, but over the years planks had moved so that seams varied from 2 mm to 12 mm in width, and even wider in a few distorted areas. The seams were caulked with cotton in most cases, or with oaken for the wider seams. King billy pine splines were shaped and fitted in the seams, coated with epoxy glue, and firmly hammered home. After leaving the glue to dry for several days, the splines were sanded flush with the planks. As the splining was done over a two year period, some of the splined seams opened up in the summer 2007-2008. The wider ones were redone, but those that had not opened up much were left, as they would become watertight as planks expanded.

Above the water line, seams were widened out to a standard 6 mm by circular saw, caulked with cotton and filled with linseed oil putty before painting. It would have been preferable to continue the splining from the waterline to the deck level, but the cost was prohibitive.

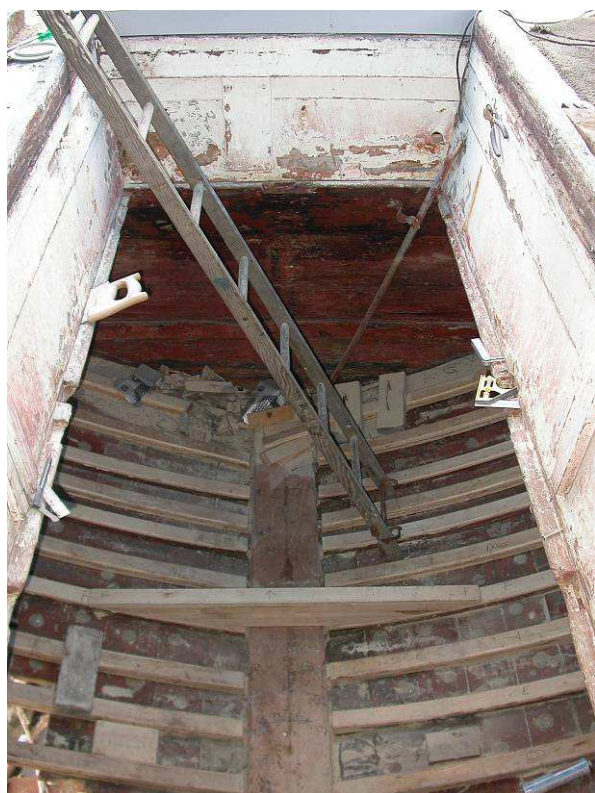
New top on keel, new ribs and a new floor in the well

the garboard plank was more a gap than a junction, up to 20 mm wide in places, as the top of the keel was badly deteriorated. The ribs in the well were very weak, and several sections of hull planking in the well were split. To rectify these problems in the well, the top 3 inches of the keel were removed (by hand, mainly by hammer and chisel) and a new keel top laminated in place for the length of the well. The original ribs, about 70 x 30 mm, were strengthened by laminating similar sized pieces on top, and new ribs installed between the old ones. As work proceeded it became apparent that the boat had been built with a centreboard through a slot in the keel, so transverse floors had never existed in the well. To

strengthen the structure, floors were installed, bolted through the hull and fixed into the keel with copper dumps.

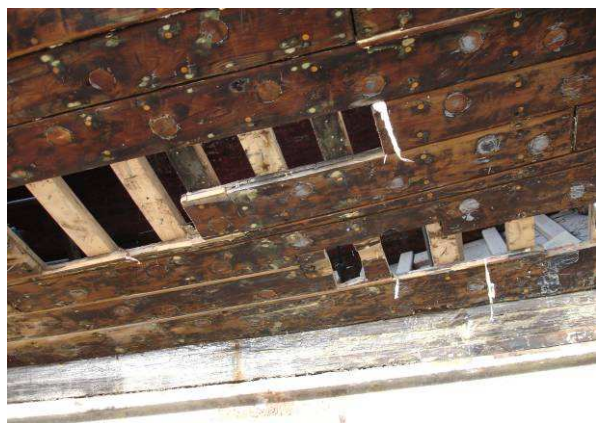
Split planks removed on starboard side

The split hull planks were removed and new celery top pine planks shaped and screwed into place. This involved replacing about six plank sections, between a metre and two metres in length. One section of the garboard plank that had been eaten away by worm was also replaced.

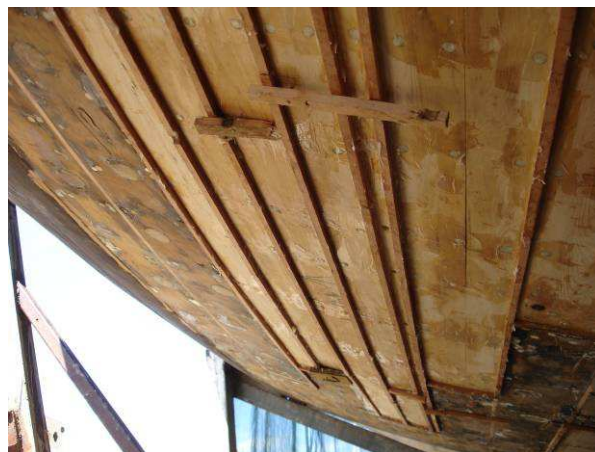
New hull planking beside the well, low down on the port side, splined and ready for sanding back.
