Parappa

NEWSLETTER OF THE BOAT "PARAPPA" ISSN 1835-4548 JUNE 2009 NO. 6

Parappa - 94 years of maintenance and modernisation

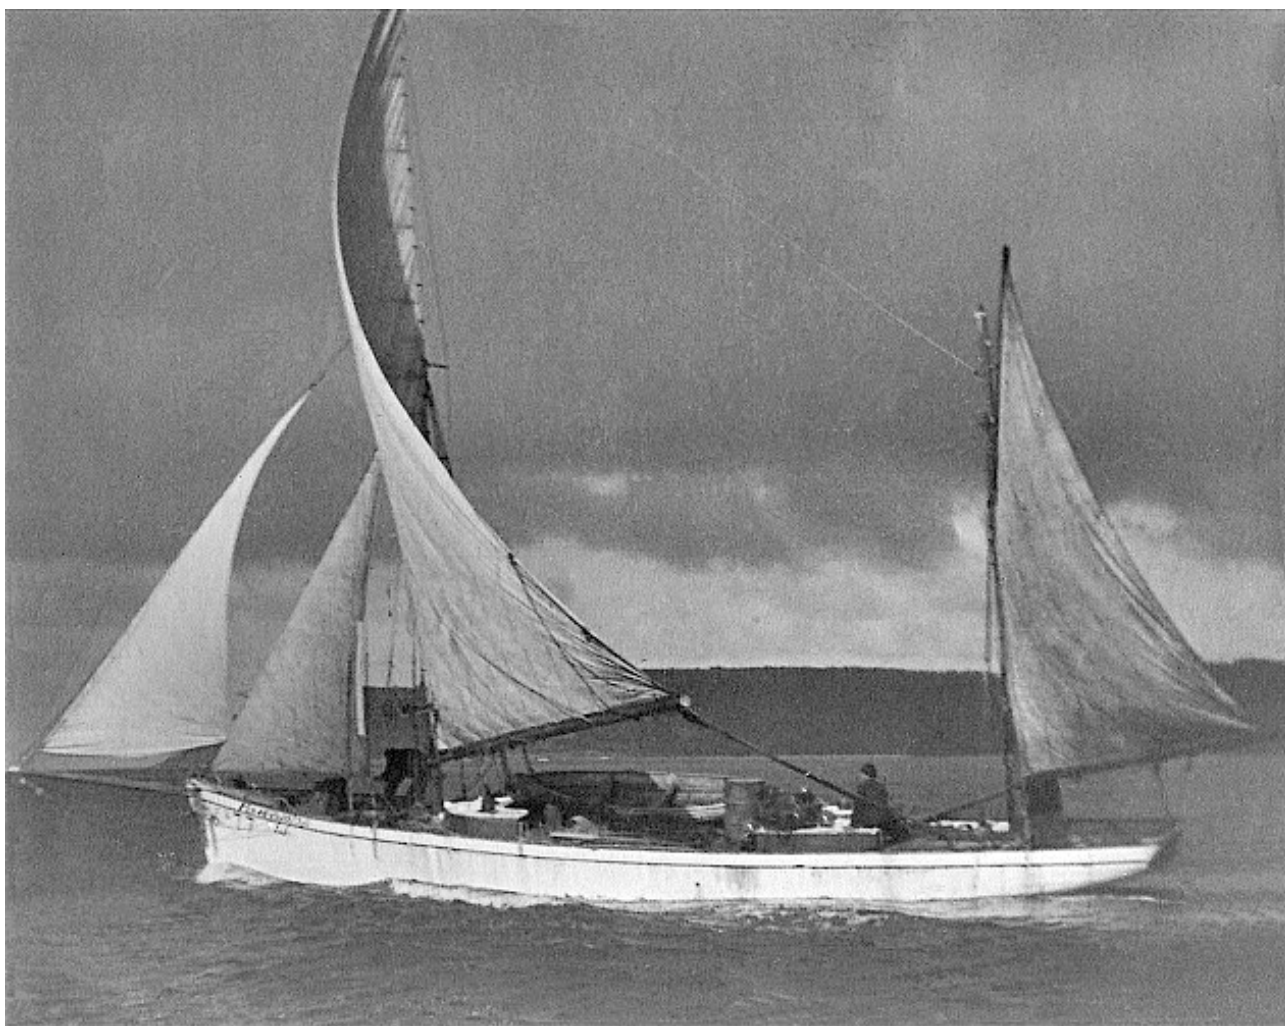
Parappa south of Kinghorne Point, D'Entrecasteaux Channel. This photo was probably taken after the Second World War, when the gaff rig had been replaced by bermudan rig. A wheelhouse had not yet been added, and steering was still by tiller. The foredeck had not been raised, and the long bowsprit was still in place. Note the wooden dinghy, for working around the craypots. (Photo supplied by Harry and Stephen Jager).
